8509 Scarboro Court
Box Area 33-05
April 24, 2011
House Fire with Civilian Death
Incident Number 11-0044722

Submitted by Battalion Chief Barry C. Reid
Incident Commander

**8509 Scarboro Court
House Fire with One Civilian Death
April 24, 2010
11-0044722**

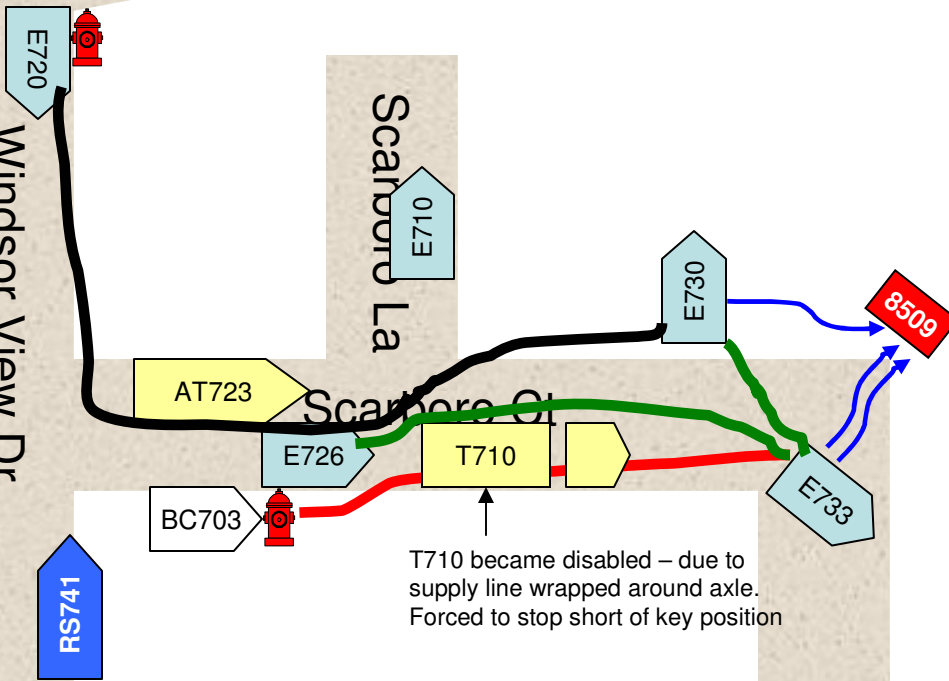
- (1) The primary supply line became entangled under T710 – picked up by the dual wheels.

The miscue with T710 also crippled the truck. As the truck attempted to proceed, the hose became wrapped around the axle and it literally began pulling the hydrant out of the ground. The truck was unable to take a tactical position, it blocked out other apparatus, and two of the three crew members became focused on removing the supply line. This delayed key tactical activities that were required.

- 4" Supply Line
- 4" Supply Line – unusable – T710 damaged
- 4" Supply Line – Plan due to primary OOS
- Attack Line

Straddling a supply line takes skill and coordination to do it effectively. On a curvy residential street it also takes additional time. It may take less time to get a couple of people and move the supply line to the side of the road (as directed in a rural incident). The officer could have also dismounted and guided T710 to avoid the hose.

Tactics still must be completed. Once it was realized that the hose was a lost cause, make a radio announcement and work around it. T710 should have continued with their assigned task.
